Monitoring Data Record

Project Title: R-2000G (I-540) COE Action ID: 199920387
Stream Name: UT Neuse River (Site 10) DWQ Number: 030114
City, County and other Location Information: I-540, Wake County (Sta.460+53 -L- to 459+80 -L- RT.)
Date Construction Completed: April 2005 Monitoring Year: (5) of 5
Ecoregion: _____ 8 digit HUC unit 03020201
USGS Quad Name and Coordinates: _____

UT Neuse River
R-2000G
Wake County

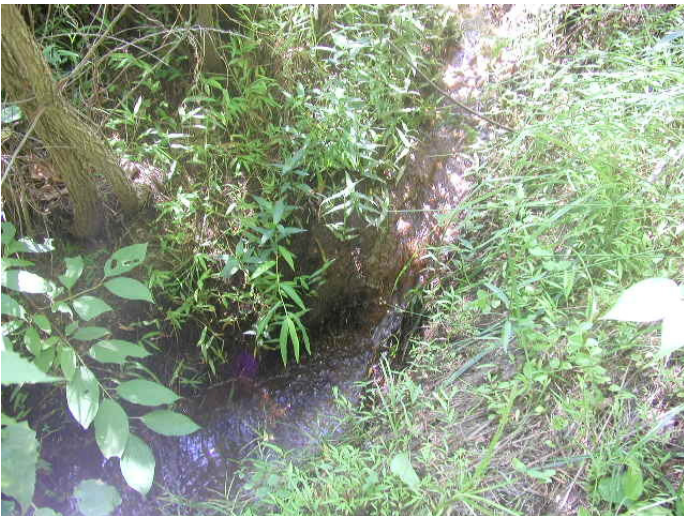
Headcut at Sta. 1+00 -RPC-
Year 5 Summer – June 2011

The UT Neuse River stream relocation is stabilized, except for, two localized areas for the Year 5 Summer evaluation. The area of bank scouring along the left bank at Sta. 1+50 –RPC- and the headcut at Sta. 1+00 –RPC- noted previously have little or no change since the last evaluation. By visual inspection throughout the 5-year monitoring period, NCDOT documented 5 bankfull events occurring during March 2007, March 2008, June 2008, January 2009, and January 2010. NCDOT proposes to discontinue channel stability monitoring at the UT Neuse River stream relocation.

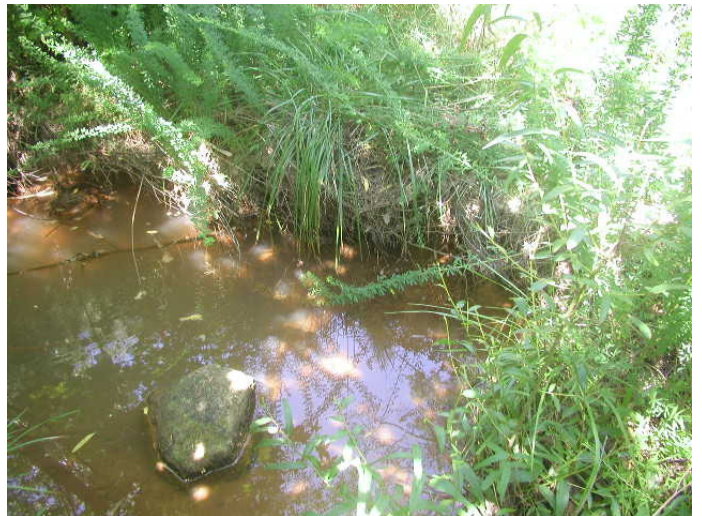
Bank scouring at Sta. 1+50 -RPC-
